Coleg Gwent Crosskeys Campus, Crosskeys

Preliminary Ecological Appraisal

May 2023

Crosskeys Campus, Coleg Gwent, Crosskeys Preliminary Ecological Appraisal and Preliminary Roost Assessment						
Revision							
1.0	04 May 2023	Charley Kennedy Assistant Ecologist	Daisy Smith Assistant Ecologist	Paul Hudson MCIEEM Principal Ecologist Paul Awher

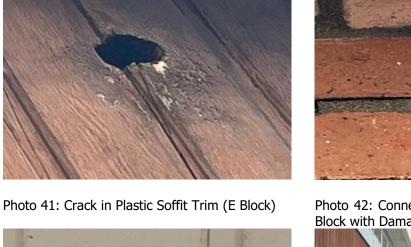
Block)

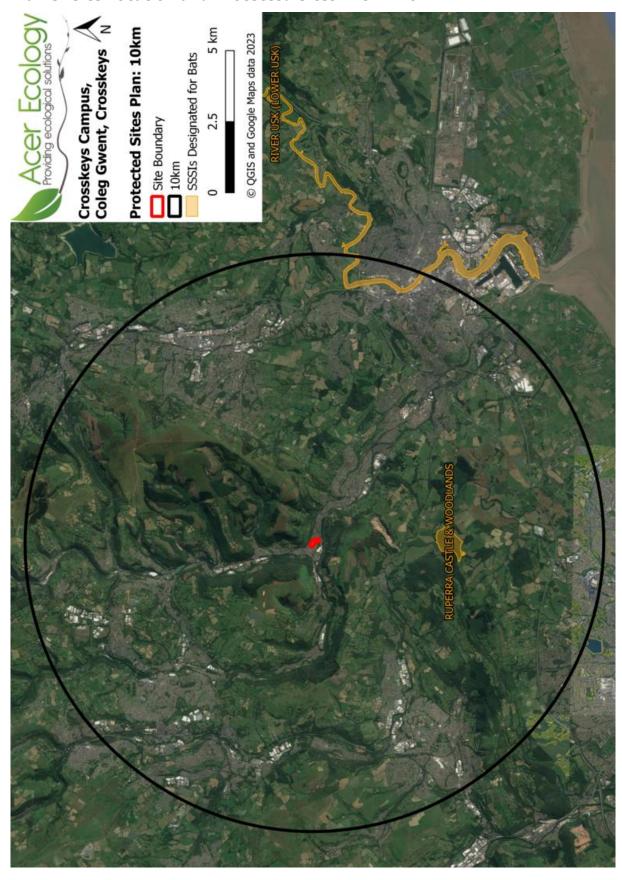
Plan 3: Site Location and Protected Sites within 2km

Information on designated sites and protected species was obtained from the sources detailed in Table 2. The legislation and policy relating to statutory and non-statutory designated sites can be found in Appendix 1. Plans 2 and 3 show the protected sites in relation to the proposed development site.
