SITE LOCATION PLAN 1:1250

Section Detail at perimeter wall

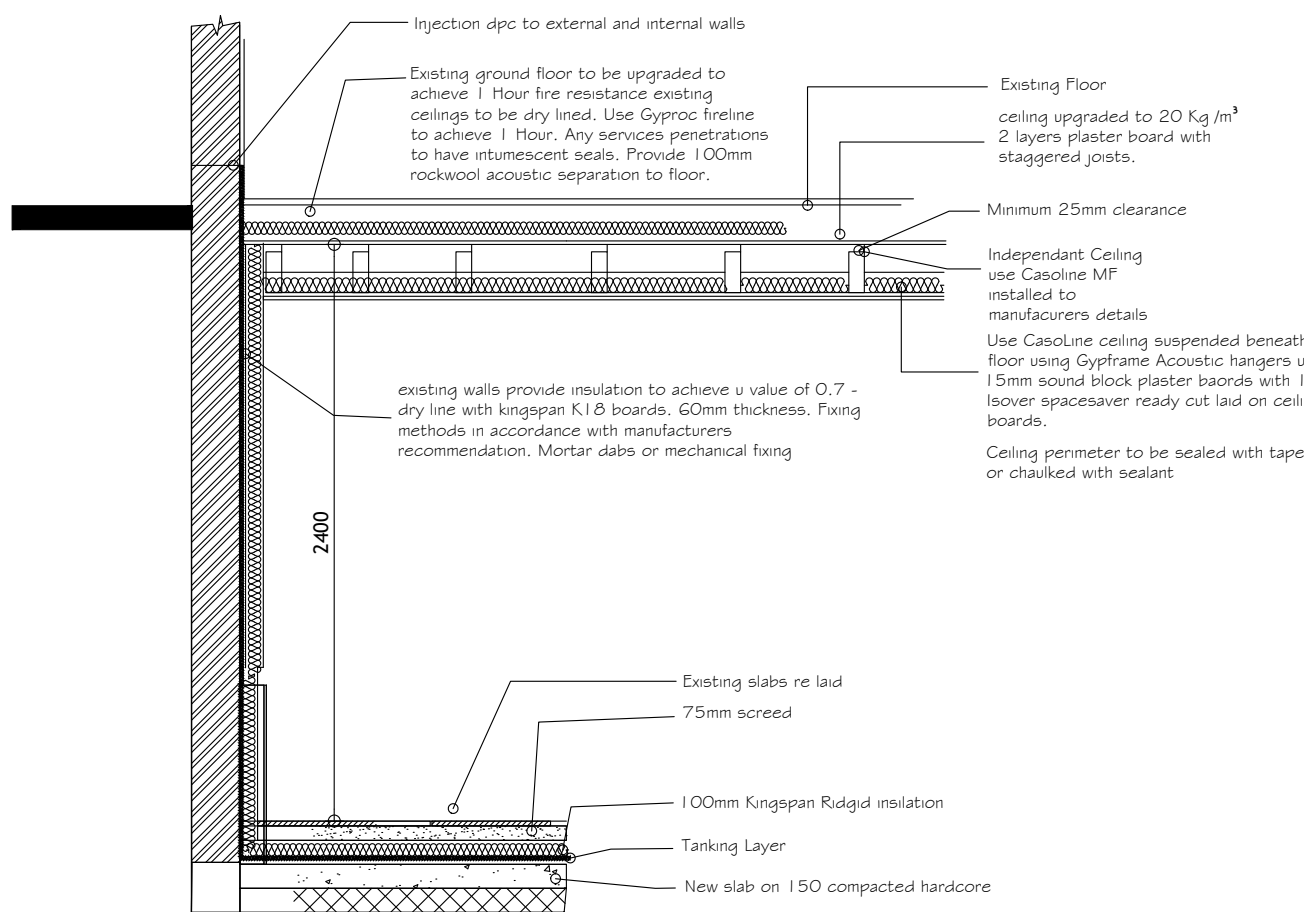
Basement Tanking Specification;-

Sika Damp-proofing Slurry
Damp-proofing and Waterproof Coating applied in accordance with manufacturers instructions. To BS
8102:1990 as a polymer-cement based waterproof coating for
Type A shallow basement structures - Grades 1, 2 and 3

The surface must be wire brushed, all mortar joints flush pointed, and the surface cleaned thoroughly to remove oils, grease, paint, bitumen or other surface contaminants. Note: glazed or smooth faced surfaces should be bush hammered or needle gunned. Soft/defective mortar joints should be raked out to a depth 12mm and repointed using the Sika® Damp-proofing Slurry mortar mix.
