Coal Mining Site Investigation Report

Frontier Medical, Newbridge Road,

Pontllanfraith, NP12 2AN

Formaction Ltd

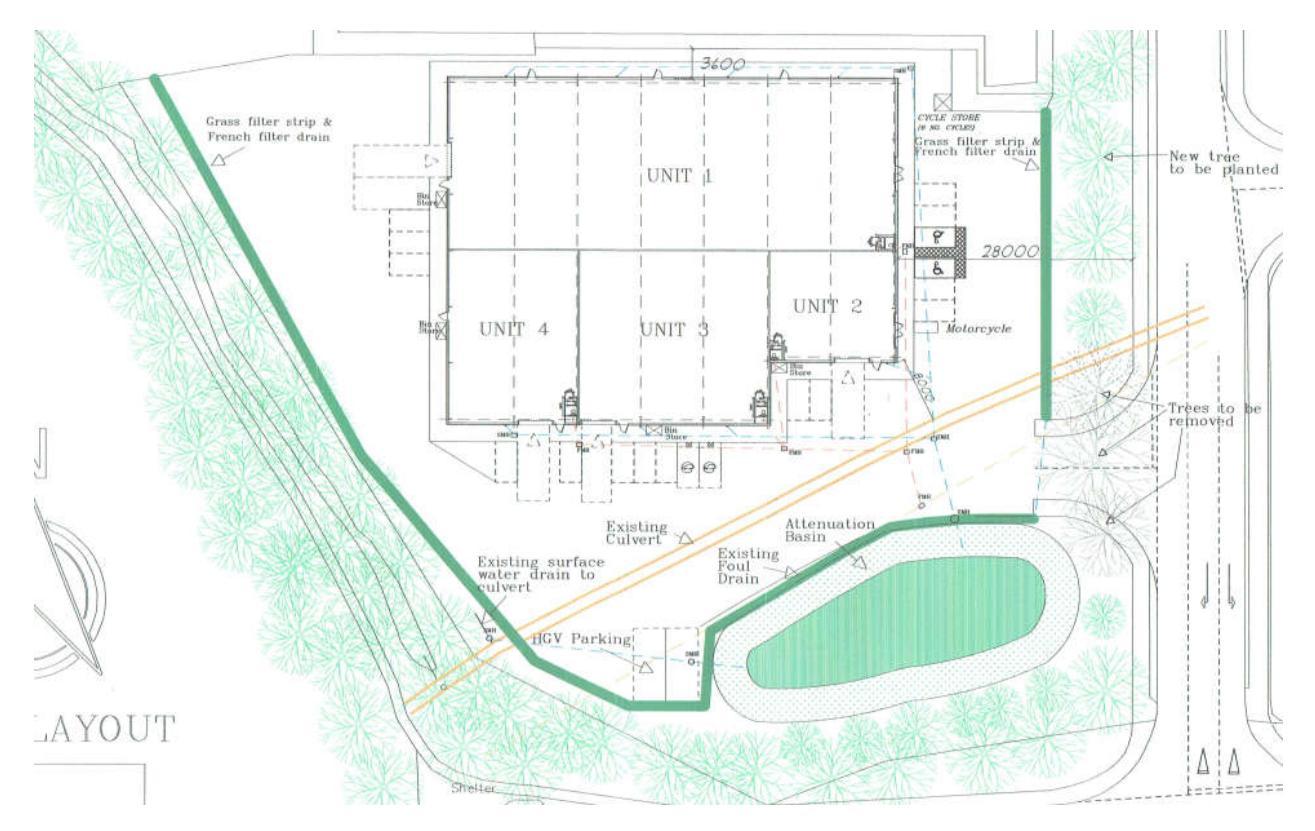
Figure 1-2 Proposed Development

The proposed development at the Site is to consist of a large commercial building structure which is to be split into 4 smaller units, associated access, parking and cycle storage as presented in Figure 1-2.

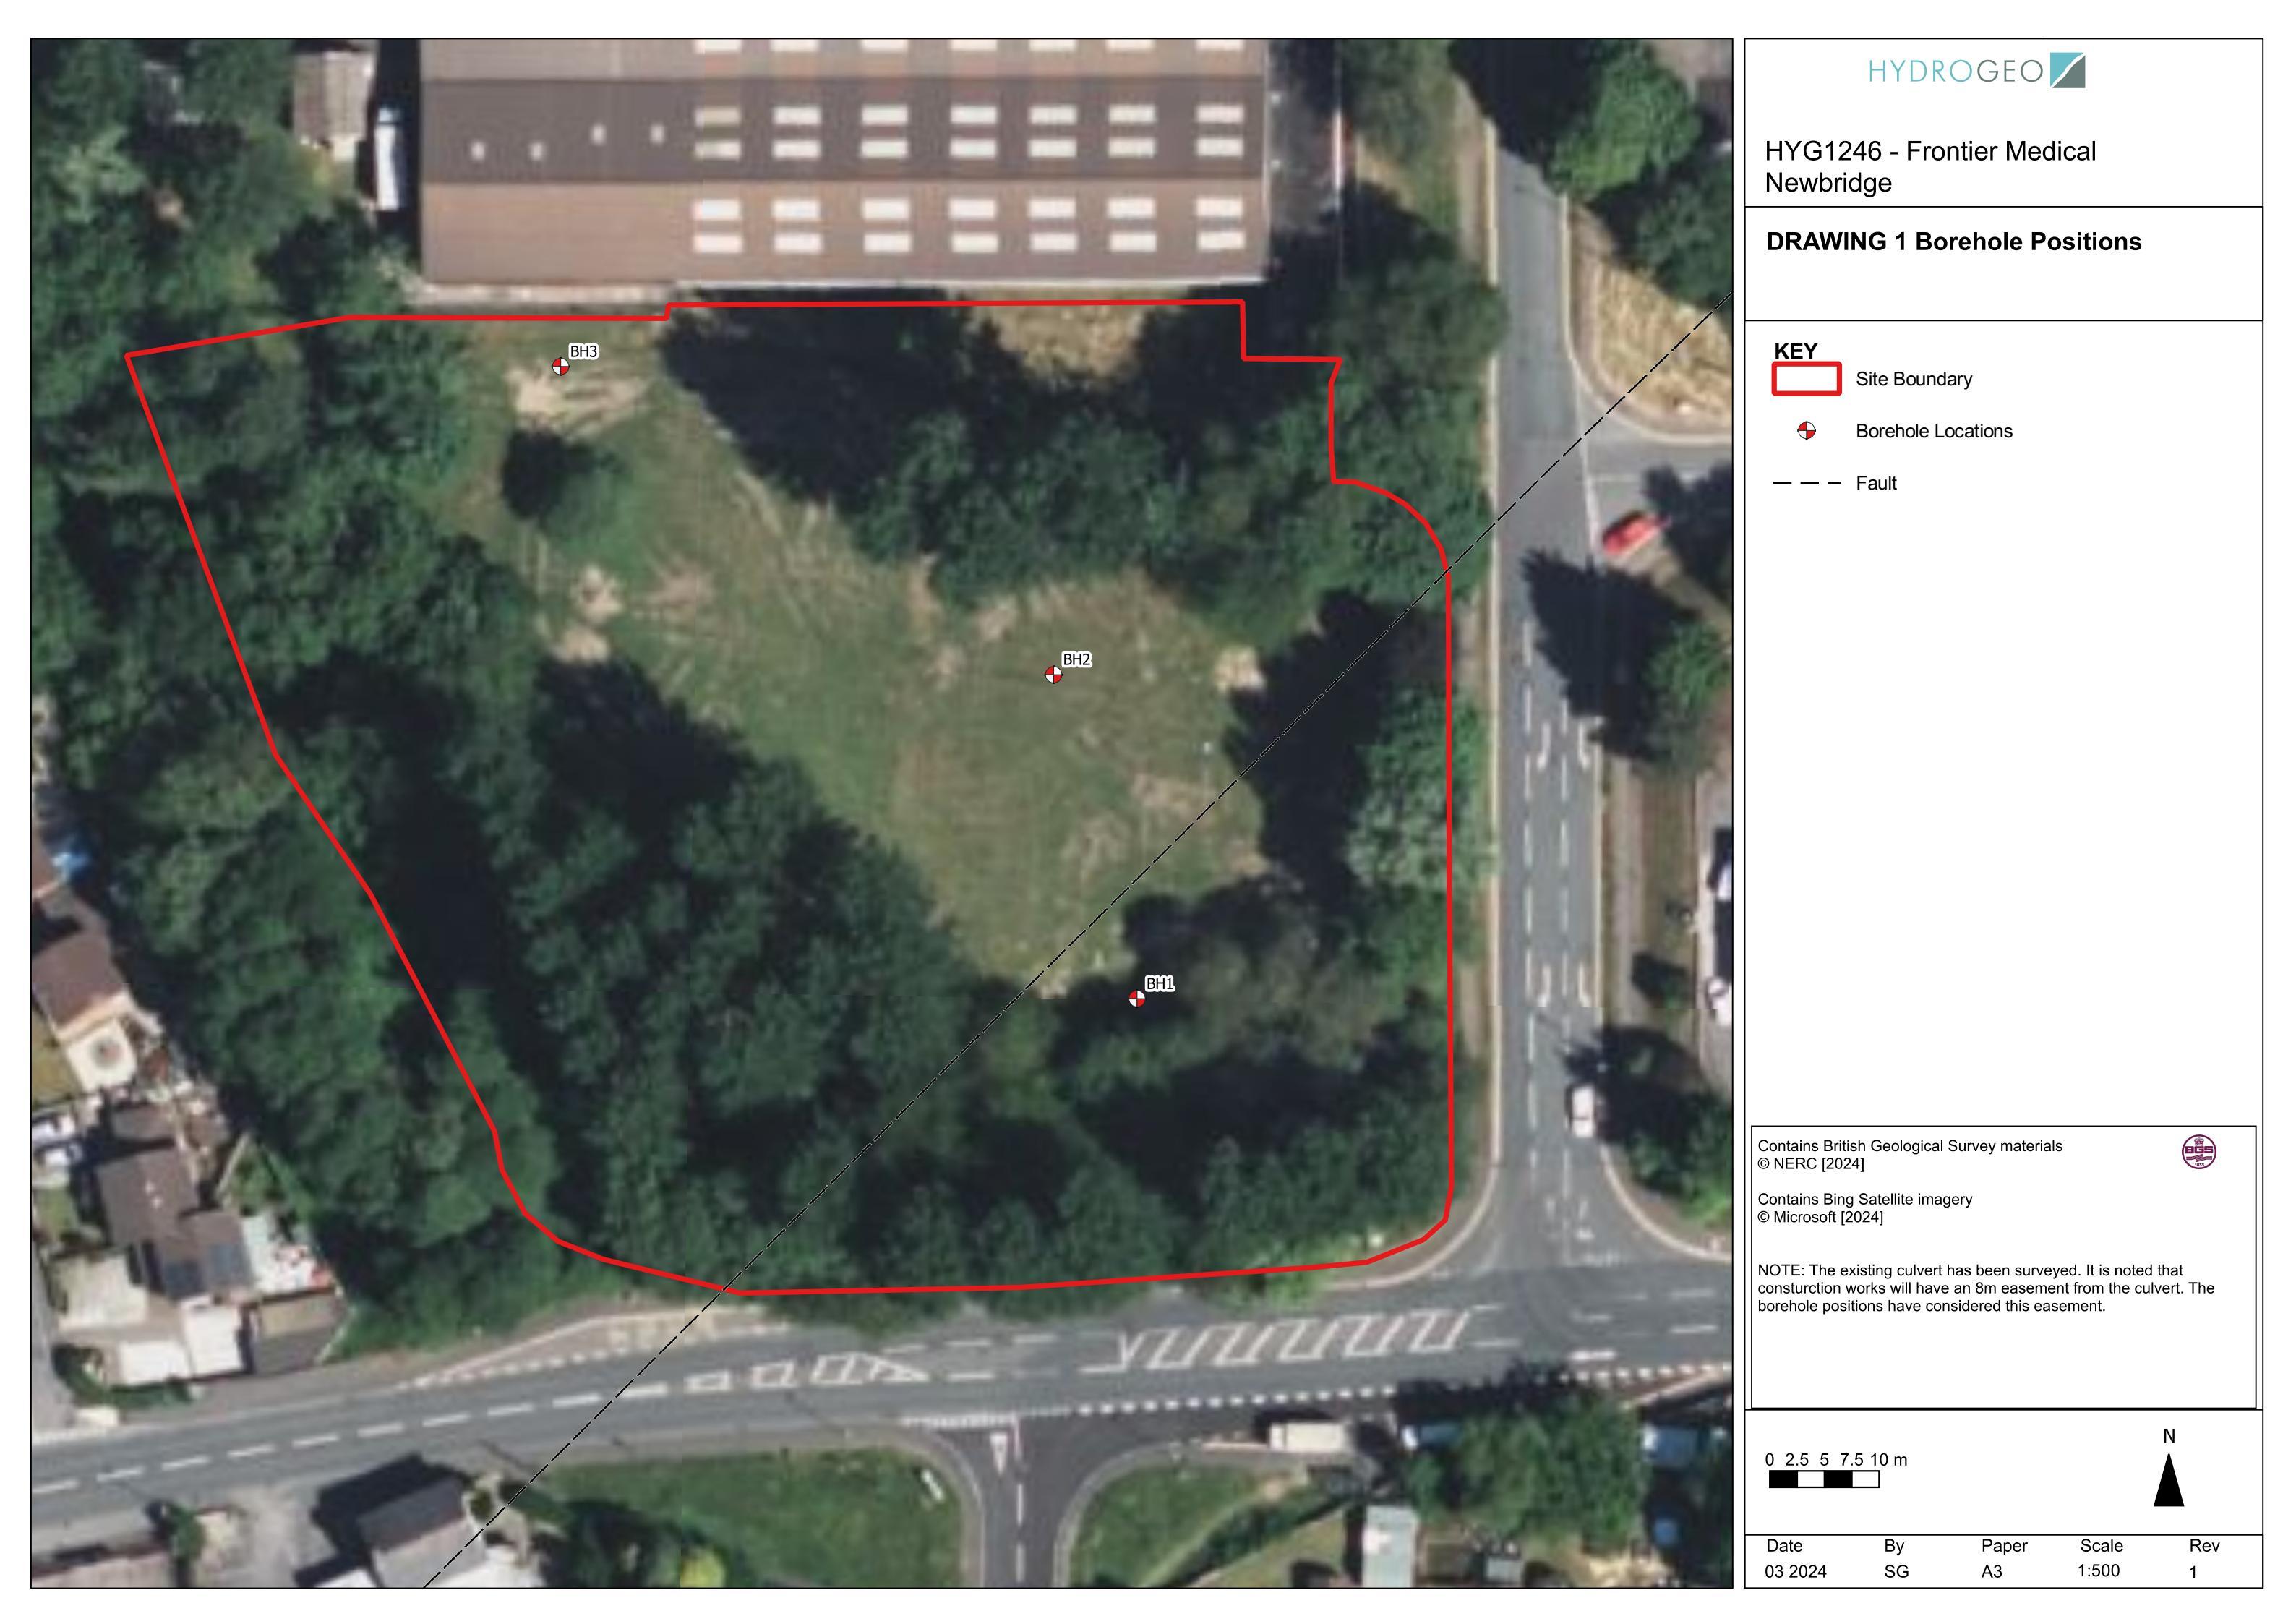
Drawing 1

The following sections present the findings of the Site Investigation including the ground conditions. Borehole logs are included as Appendix B and the borehole positions are included as Drawing 1. A cross-section through the Site detailing the findings of the intrusive investigation has been included as Drawing 2.

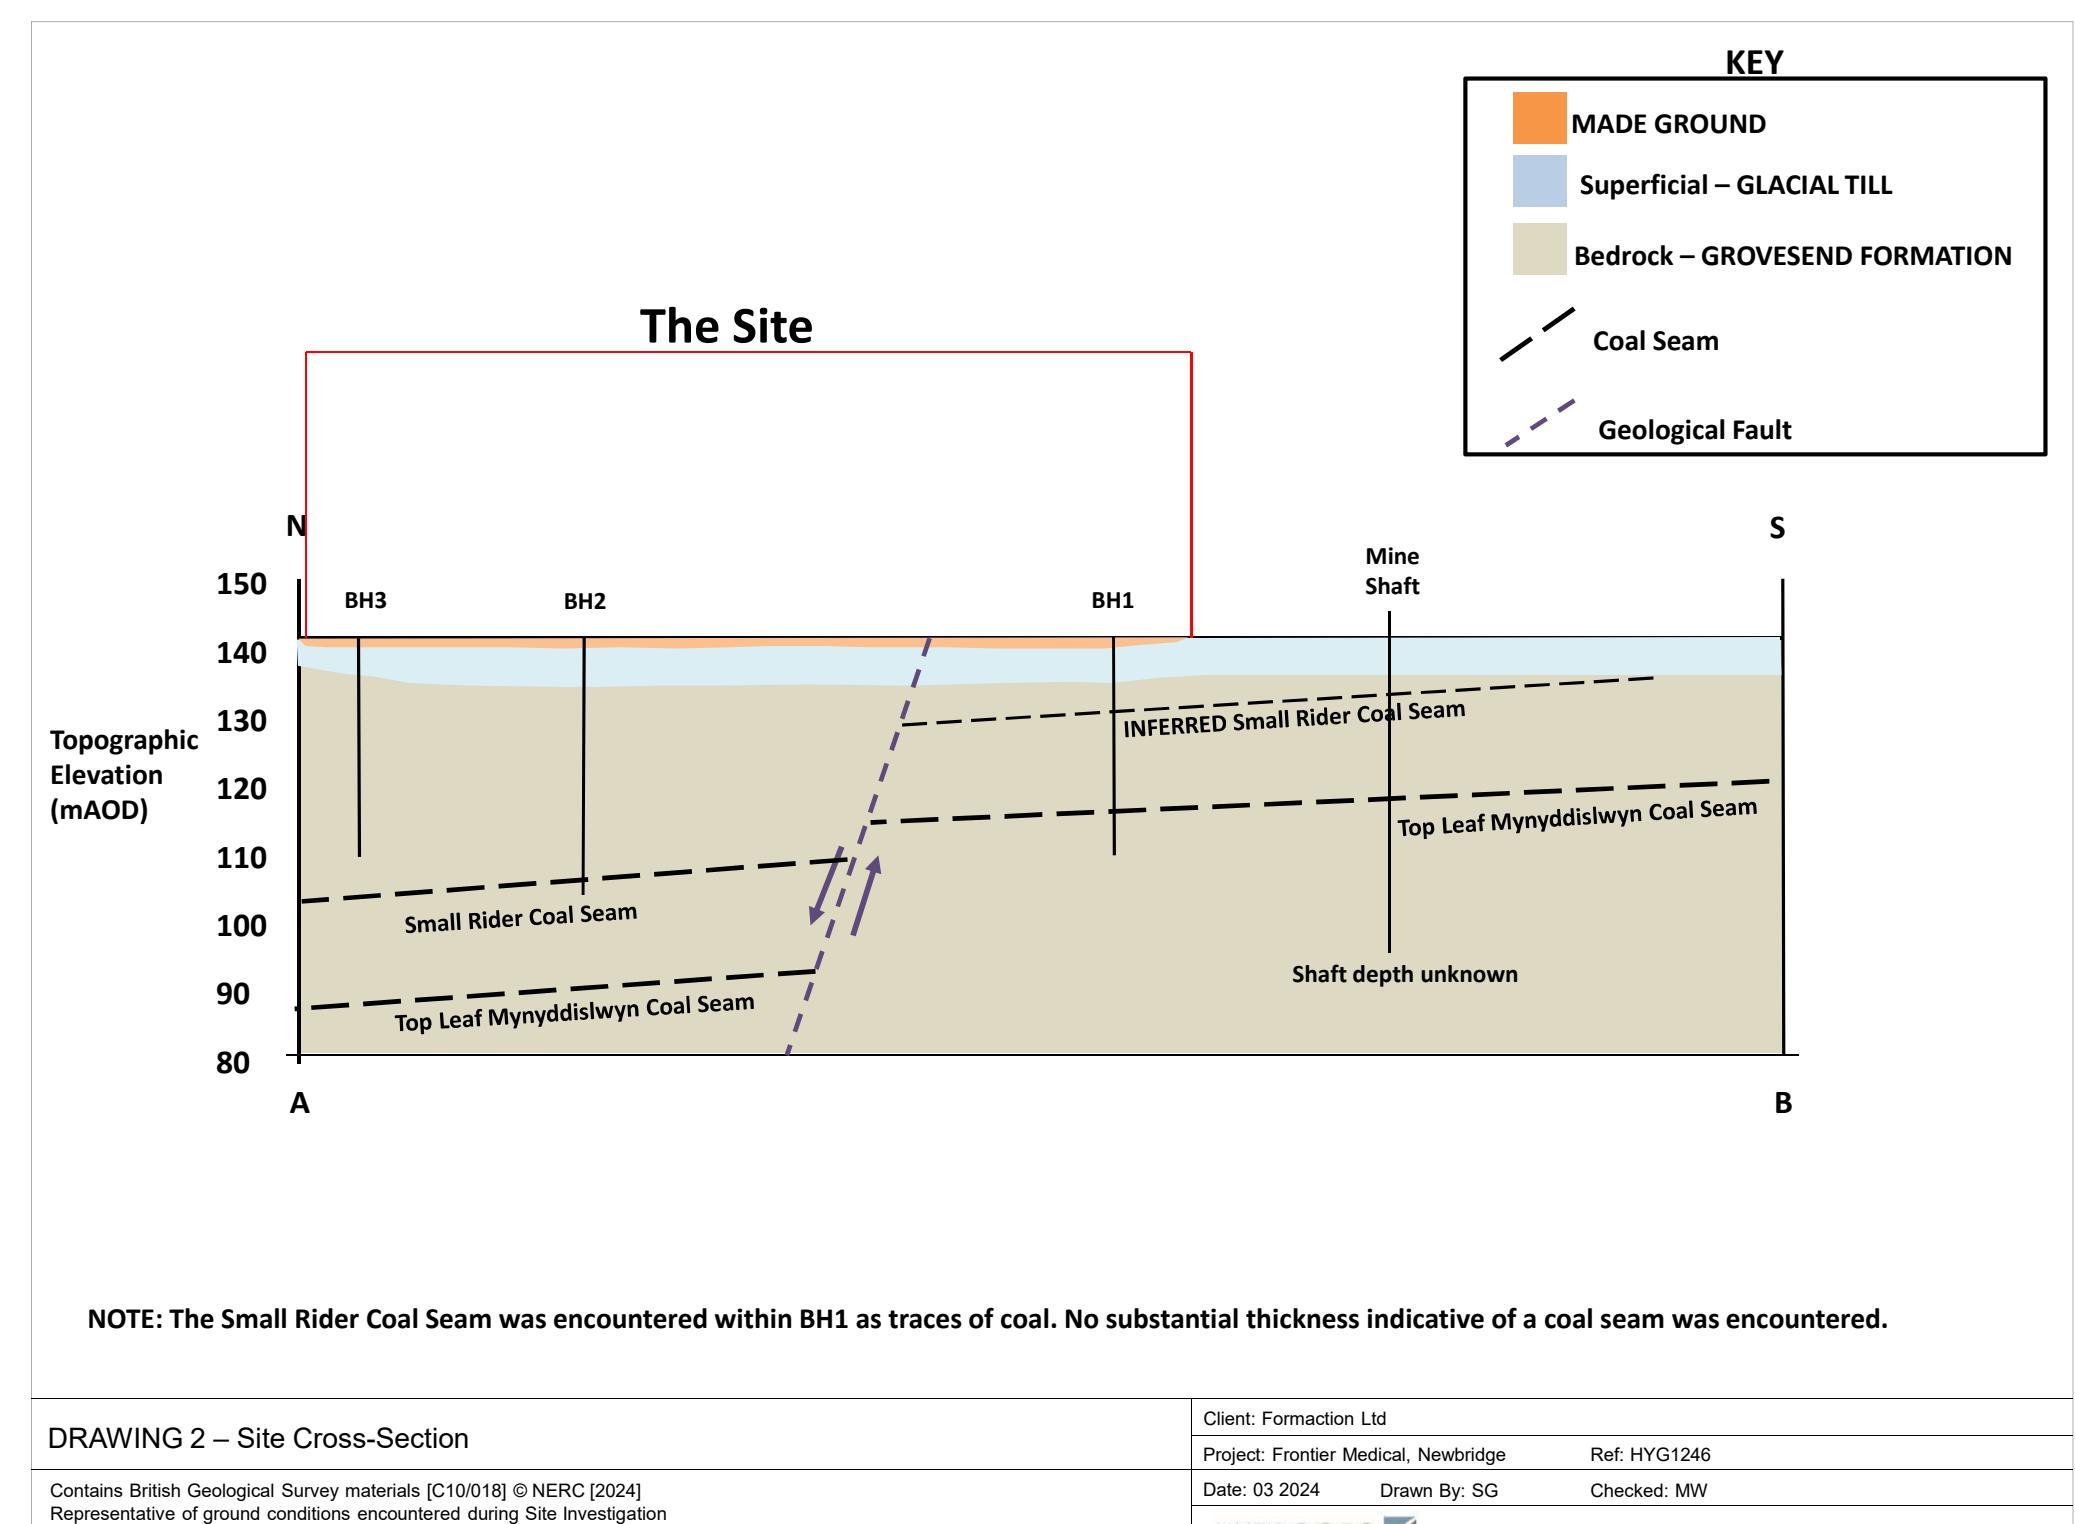
Drawing 2

Published geological data indicates that the Site is bisected by a large north-east southwest trending fault, with a downthrow to the northern side of the fault. This fault is mapped between the position of BH1 and BH2, resulting in BH2 being positioned on the downthrown side of the fault. This is reflected in the encountered ground conditions of BH2, where the Mynyddislwyn seam has not been encountered within the top 35mbgl. Additionally, the bedrock geology dips shallowly to the north / north-west beneath the site at a rate of appropriately 5°, taking the Mynyddislwyn seam deeper beneath the northern portion of the Site.
